CASE STUDY

Aggregates

NEW PULSE-CLEAN DUST EXTRACTOR FOR CEMENT PLANT

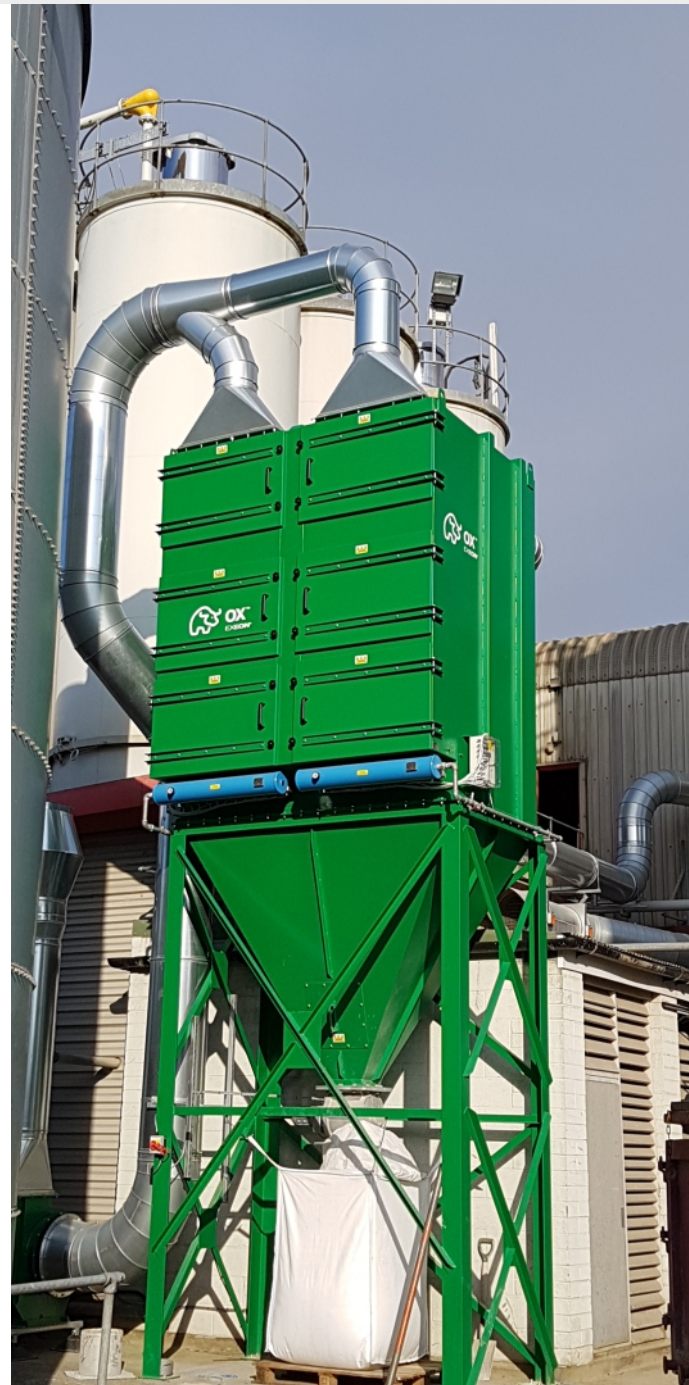
Exeon installed an OX-type reverse jet bag filter system and a completely new ductwork system. This reduced the maintenance costs on the system by 75%, in addition to the time saved by fewer maintenance visits, saving service costs.

The new ductwork system had smooth-bore internals and swept bends for maximum efficiency of extraction. The ductwork was clip-together with no internal obstructions.

Exeon designed the discharge to accommodate the tonne bag used by the site, to facilitate much quicker and easier waste disposal process.
