CASE STUDY

DUST EXTRACTION FOR SHOE MANUFACTURER

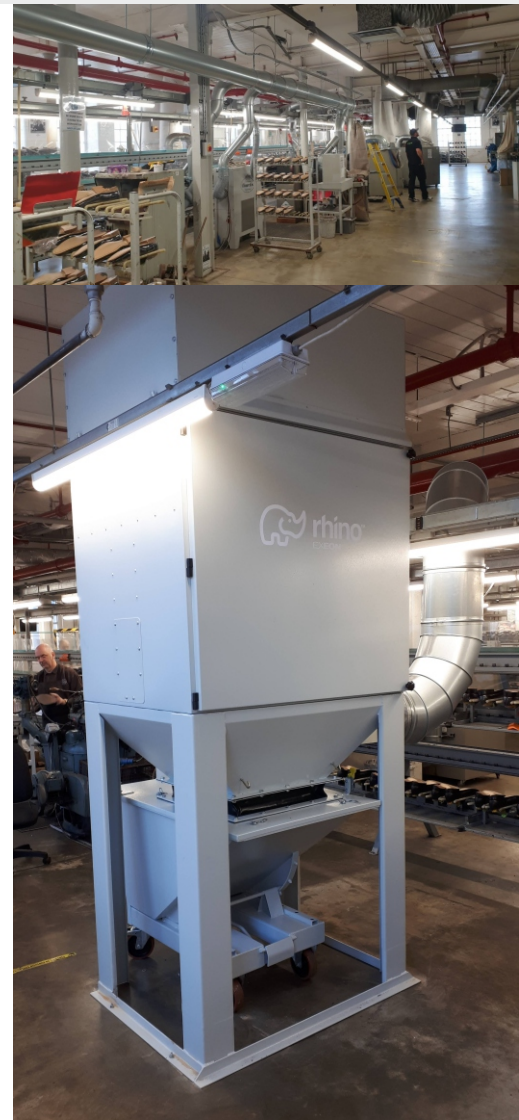
Exeon supplied and installed a Rhino 40 Extraction system on the process.

The Rhino 40 was provided with a Tipping Skip type discharge bin, allowing for very high dust loading with minimal maintenance headache.
